FULL RESERVE STUDY

The Plantation on Pelham Property Owners Association, Inc.

Greenville, South Carolina

August 6, 2015

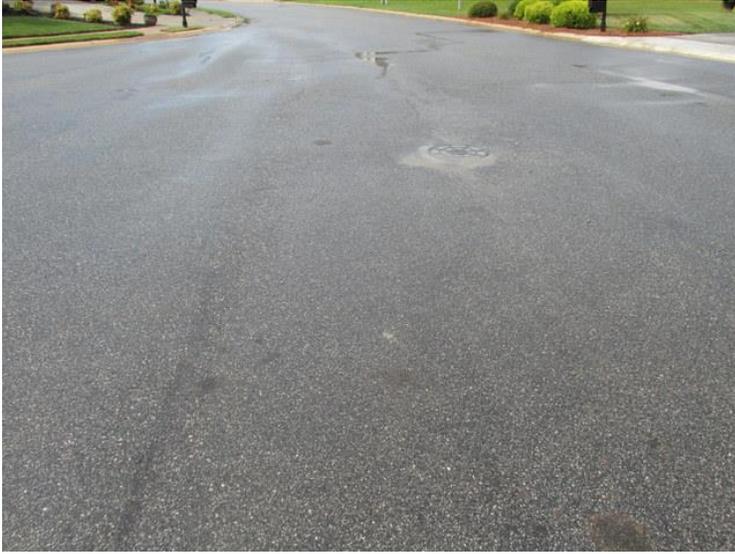
Asphalt pavement – Rivoli Lane

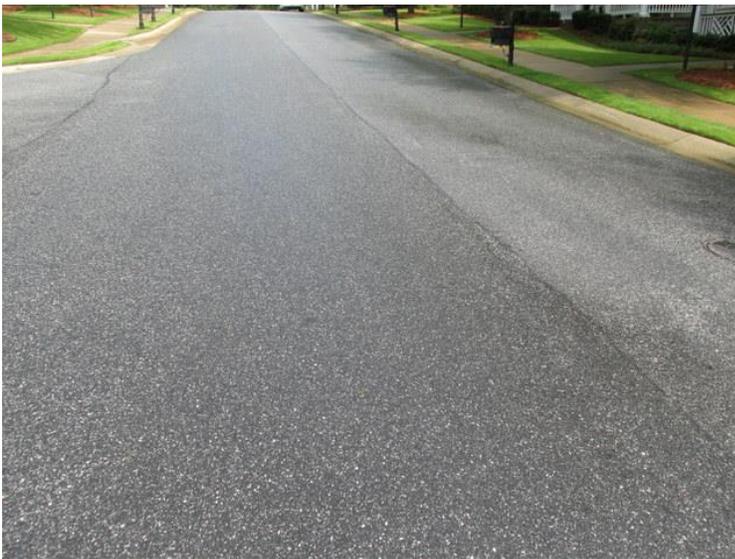
Asphalt pavement – Rivoli Lane

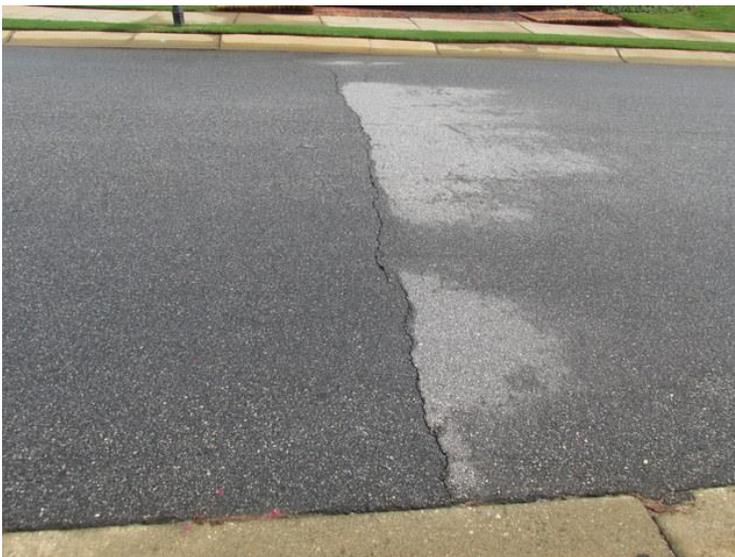
Asphalt pavement – Lowther Hall Lane

Note: Transverse crack

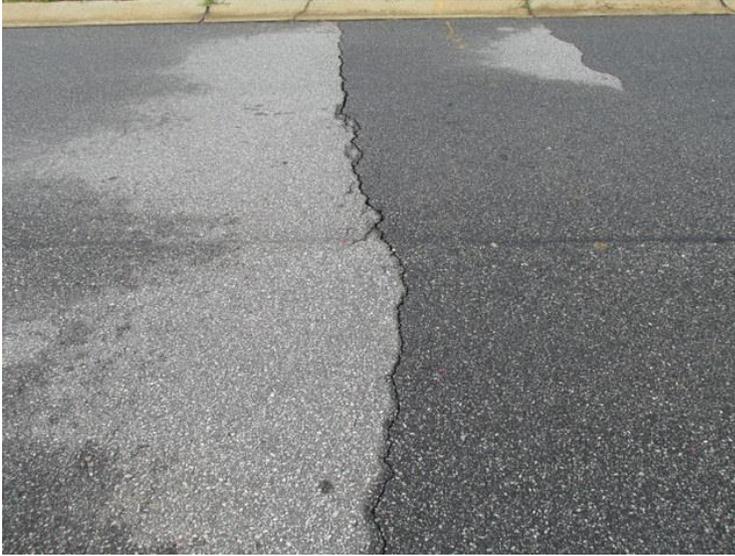
Asphalt pavement – Lowther Hall Lane

Note: Transverse crack

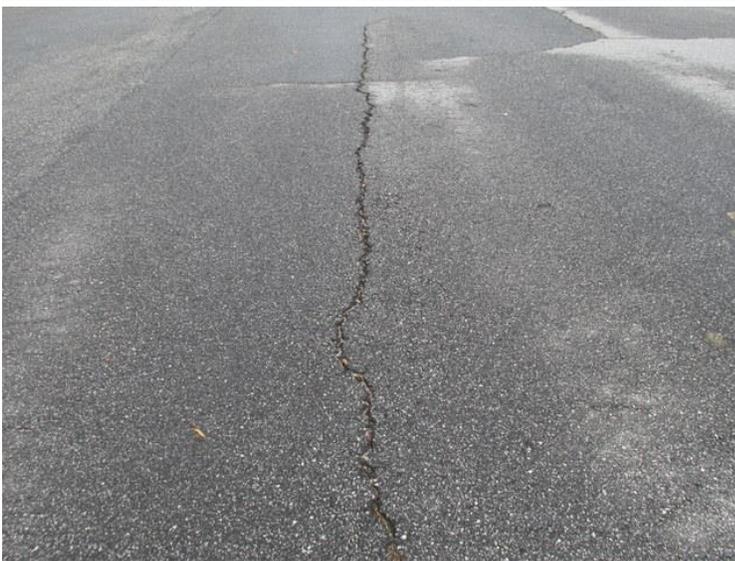
Asphalt pavement – Micasa Court

Note: Crack at cul-de-sac

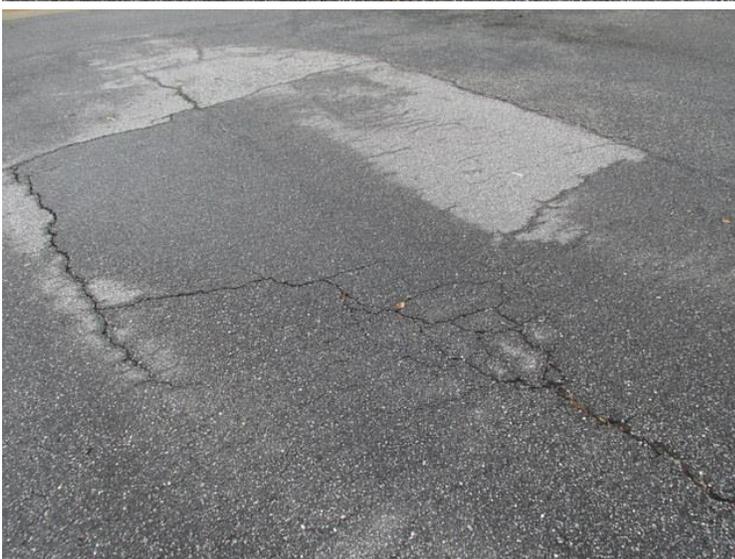
Asphalt pavement – Micasa Court

Note: Cracks at cul-de-sac

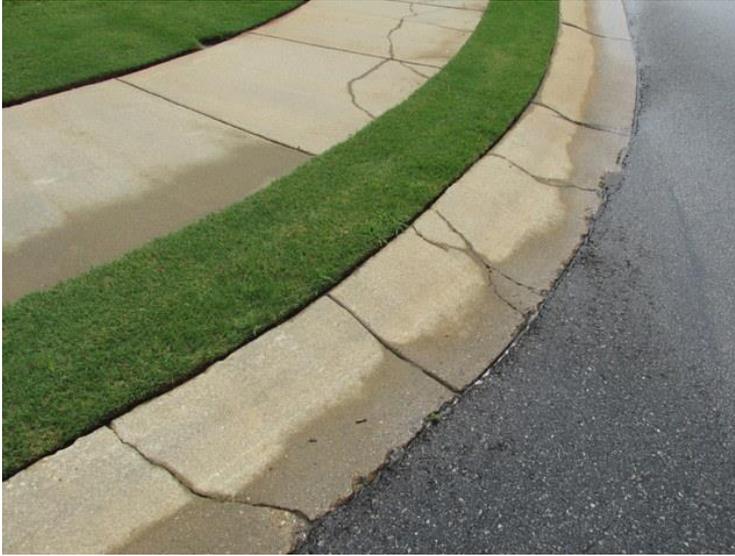
Cracked concrete gutter sections and concrete sidewalk sections

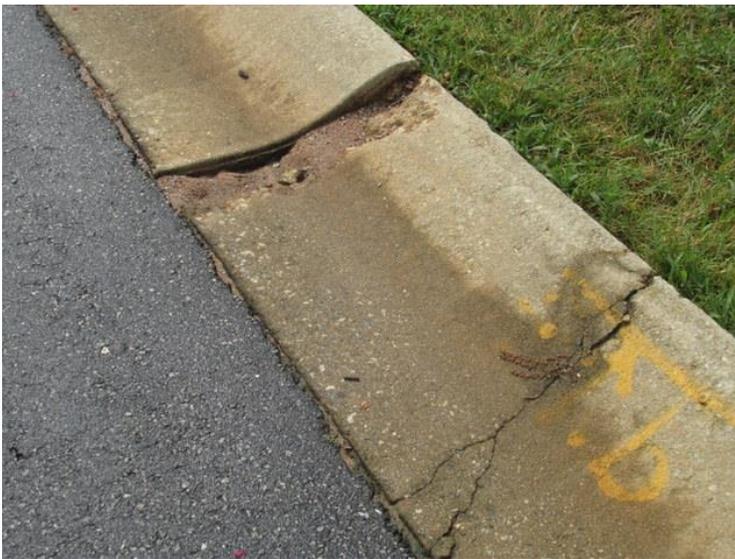
Cracked and settled concrete gutter section

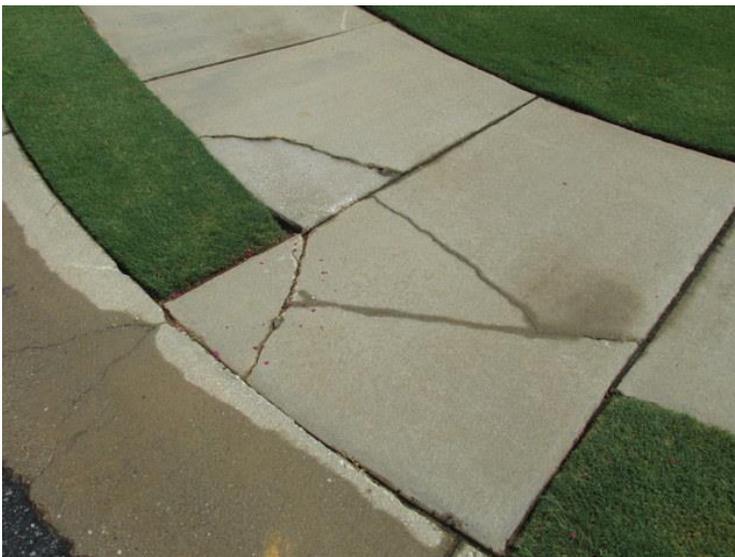
Cracked concrete sidewalk sections

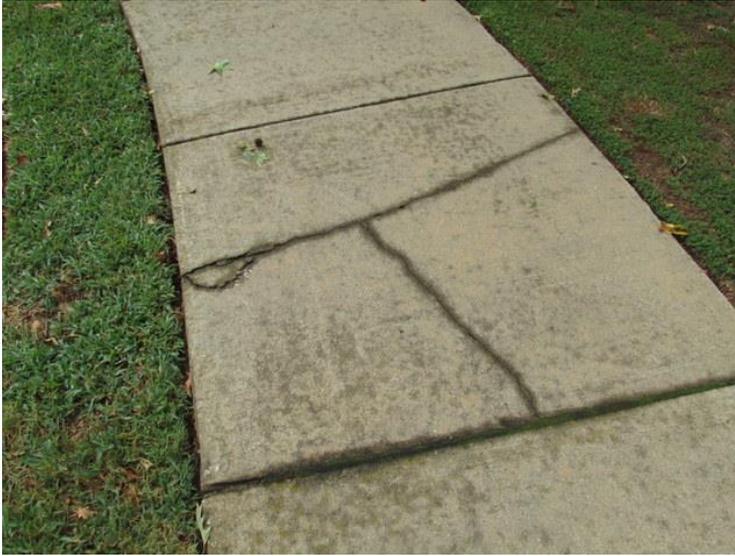
Cracked concrete sidewalk section

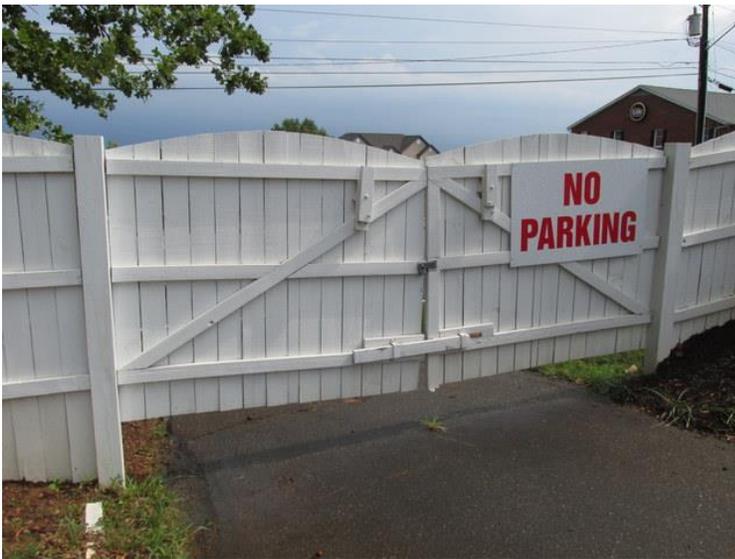
Wood gates at service drive

Note: Association should fund maintenance and replacement of gates through the operating budget

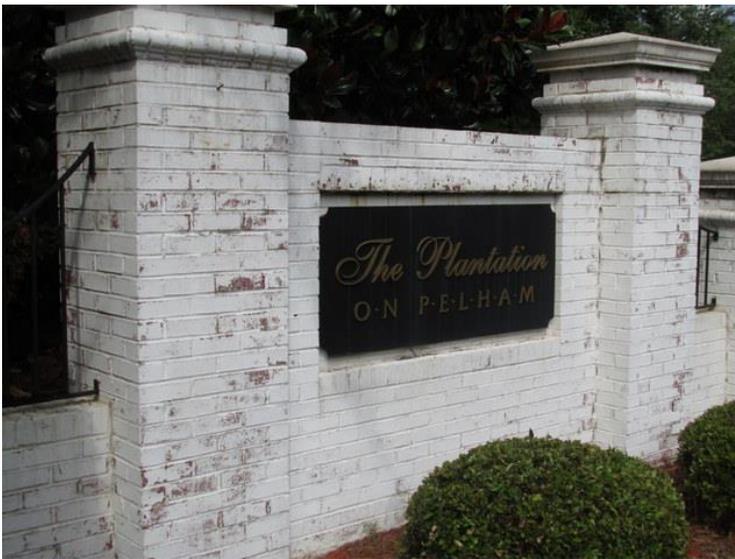
Masonry wall at community entrance

Note: Poor paint finishes

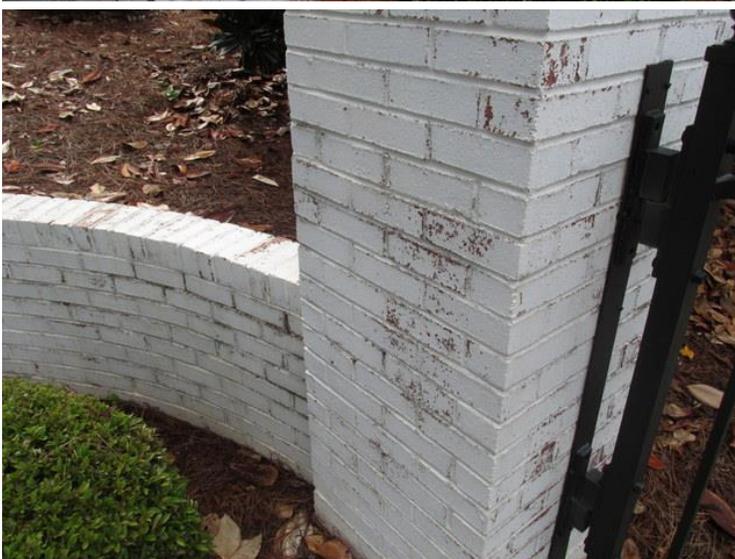
Masonry wall at community entrance

Note: Poor paint finishes

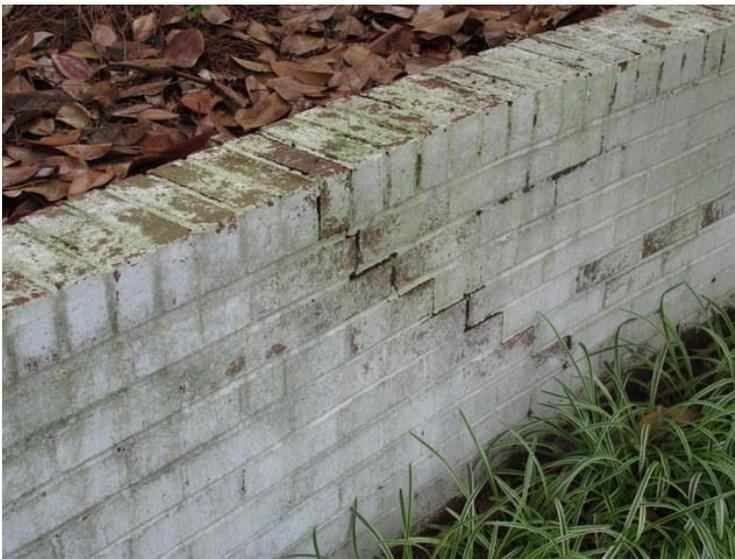
Masonry wall at community entrance

Note: Step crack and poor paint finishes

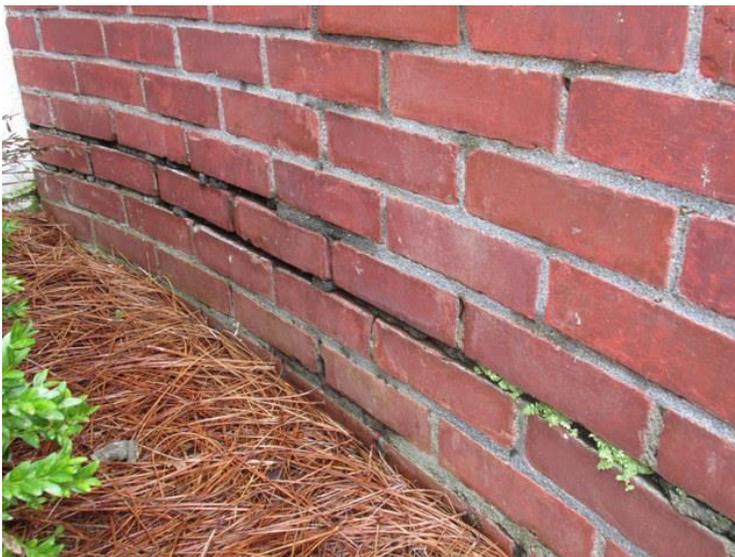
Masonry wall at clubhouse

*Note: Mortar deterioration and
vegetation growth*

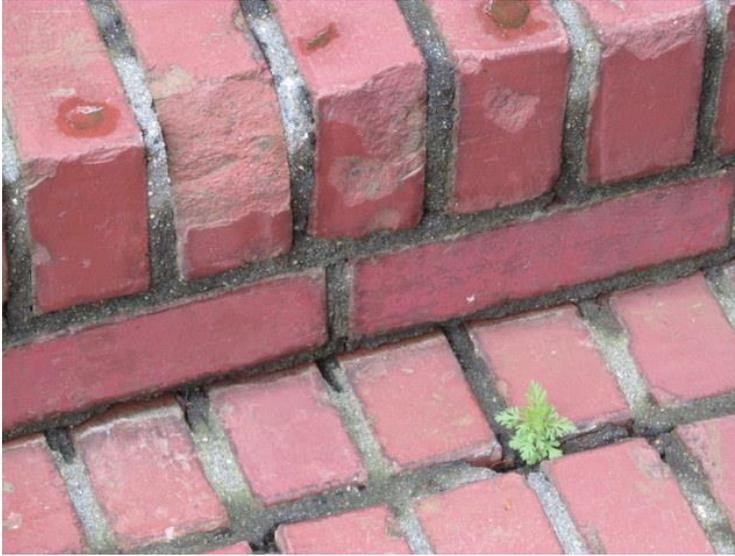
Masonry at clubhouse

Note: Mortar deterioration, spalled masonry and vegetation growth

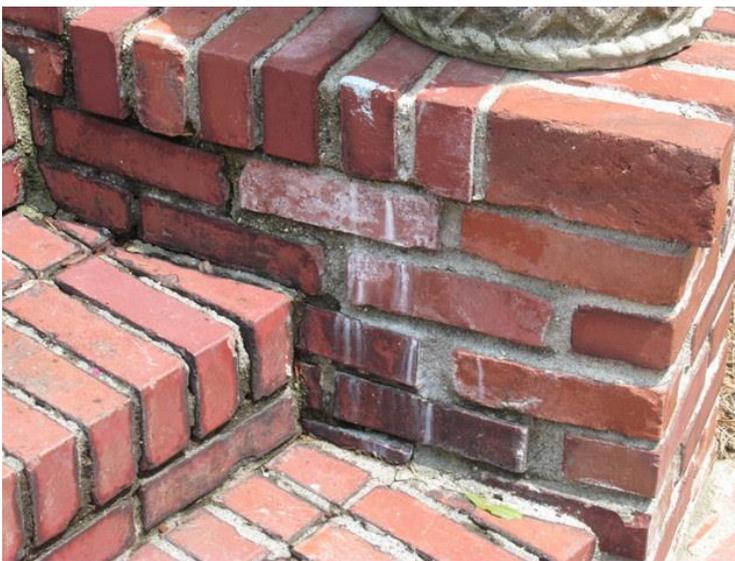
Masonry at clubhouse

Note: Mortar deterioration and efflorescence

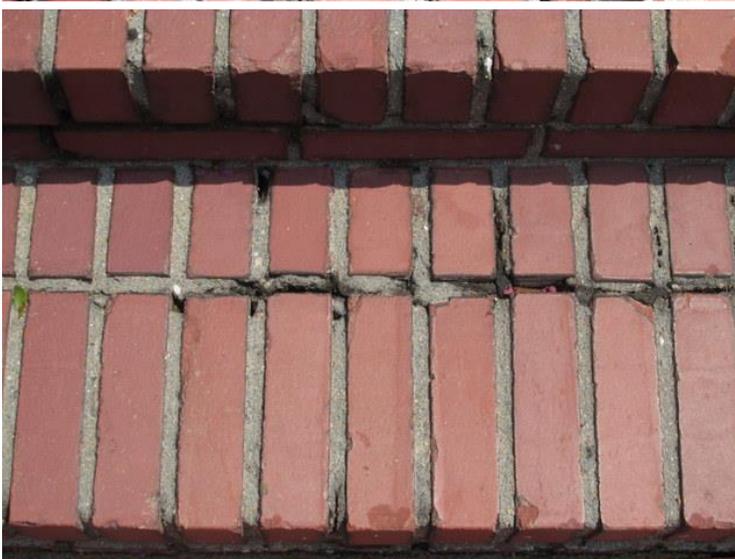
Masonry at clubhouse

Note: Mortar deterioration

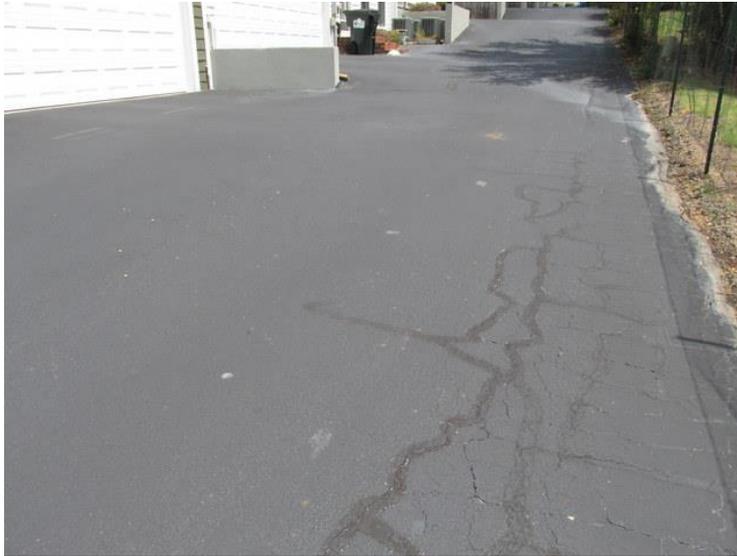
Asphalt pavement at alley

Note: Crack formation at edge

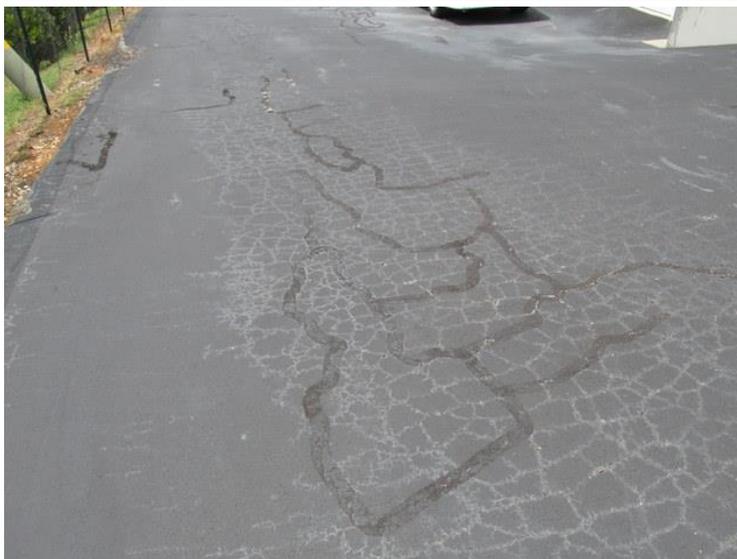
Asphalt pavement at alley

Note: Cracks

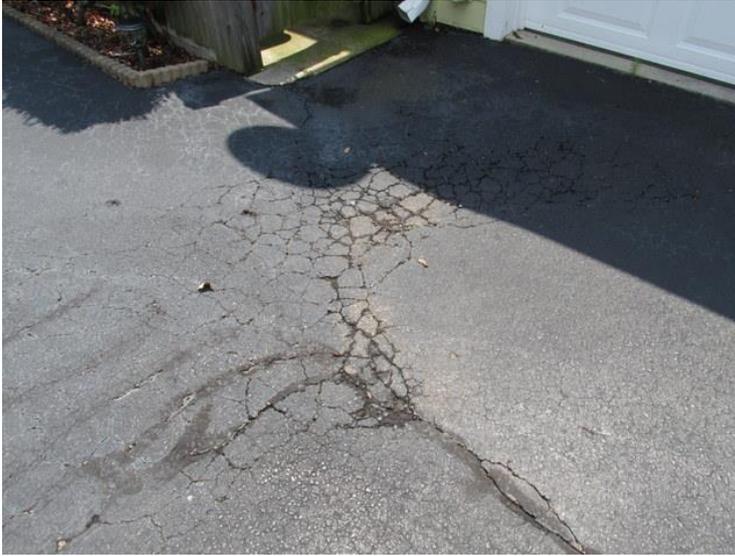
Asphalt pavement at alley

Note: Cracks and pavement deterioration

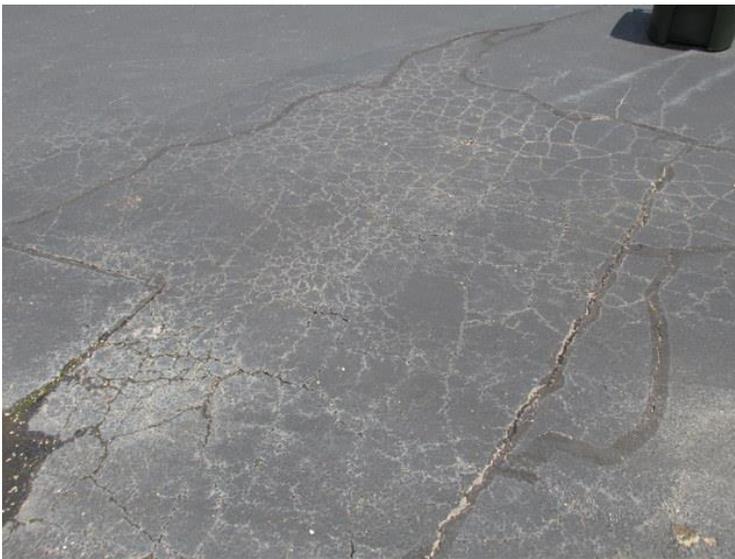
Asphalt pavement at alley

Note: Cracks and pavement deterioration

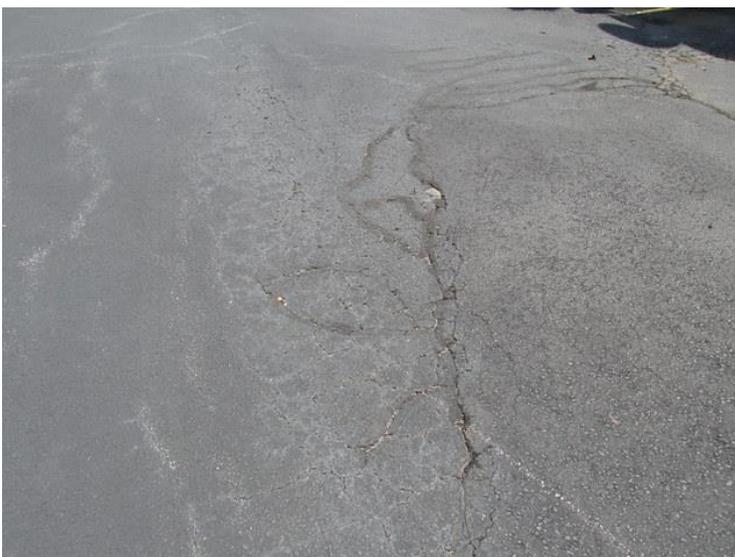
Asphalt pavement at alley

Note: Cracks and pavement deterioration

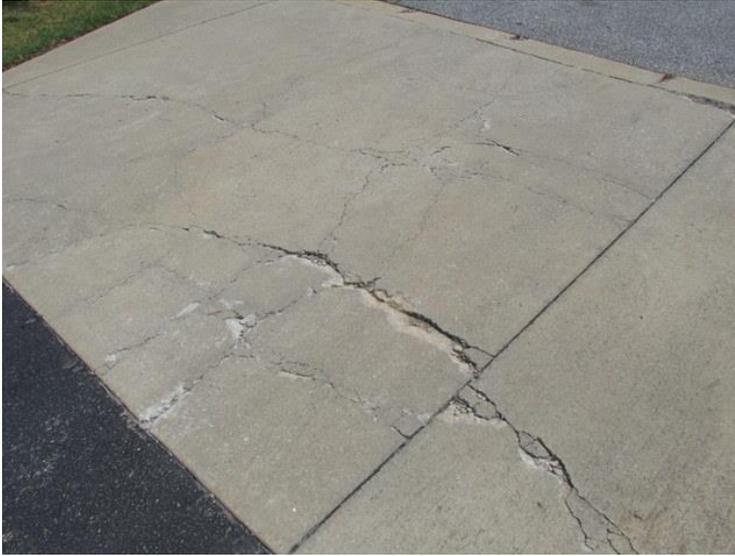
Concrete apron at entrance to alley

Note: Cracks and concrete spalls
