April 12, 2016

Re: Mechanically Stabilized Earth Retaining Wall Review  
Cobble Stone  
Putney Bridge Lane  
Simpsonville, South Carolina  
ECS Project No. 39-1298

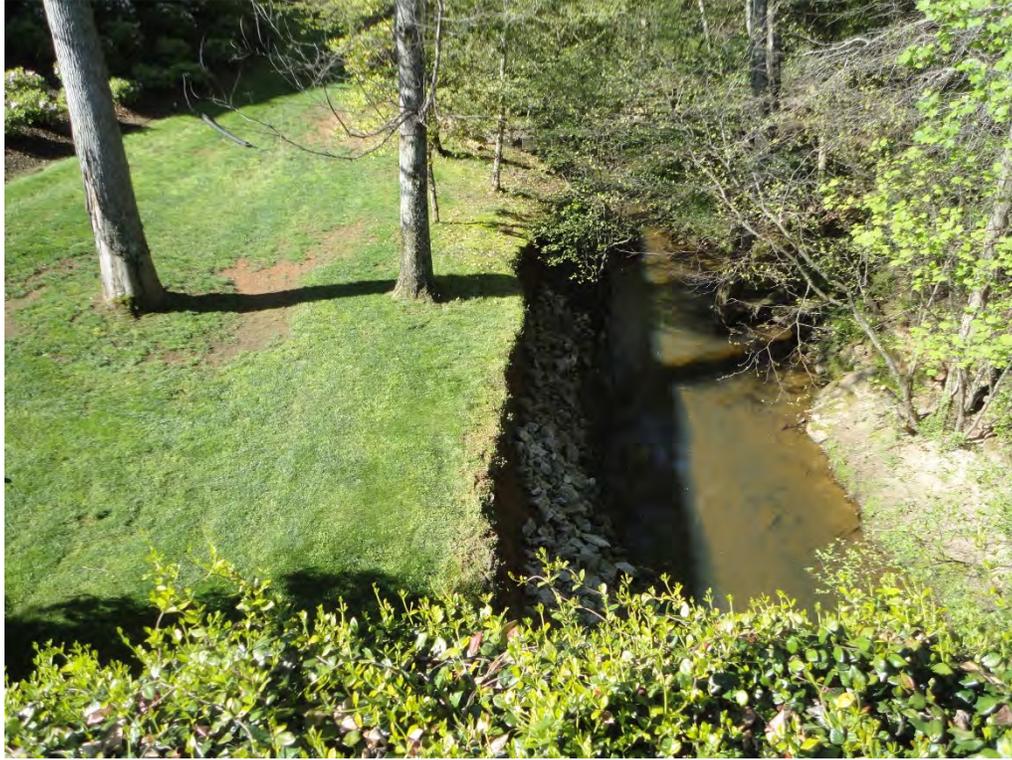
Photo 5 - Embankment instability west of south end of culvert beneath west MSEW.

Formal assessment of the embankment instability along the south bank of Peters Creek west of the culvert was beyond the scope of this retaining wall review. Evidence of tension cracks were observed in the ground surface south of the embankment crest. However, continued/progressive embankment failures could expose the south culvert foundation and undermine the south wing of the west MSEW. The embankment instability appears primarily related to the embankment geometry, engineering properties of the exposed soils, and flow of water in Peters Creek.

We strongly recommend that the embankment stability be formally evaluated by a qualified geotechnical engineer and that an engineered solution be developed to permanently stabilize/repair the embankment. The final engineered solution may also require assistance from a qualified civil engineer to aid in considering flow within Peters Creek. It is important to

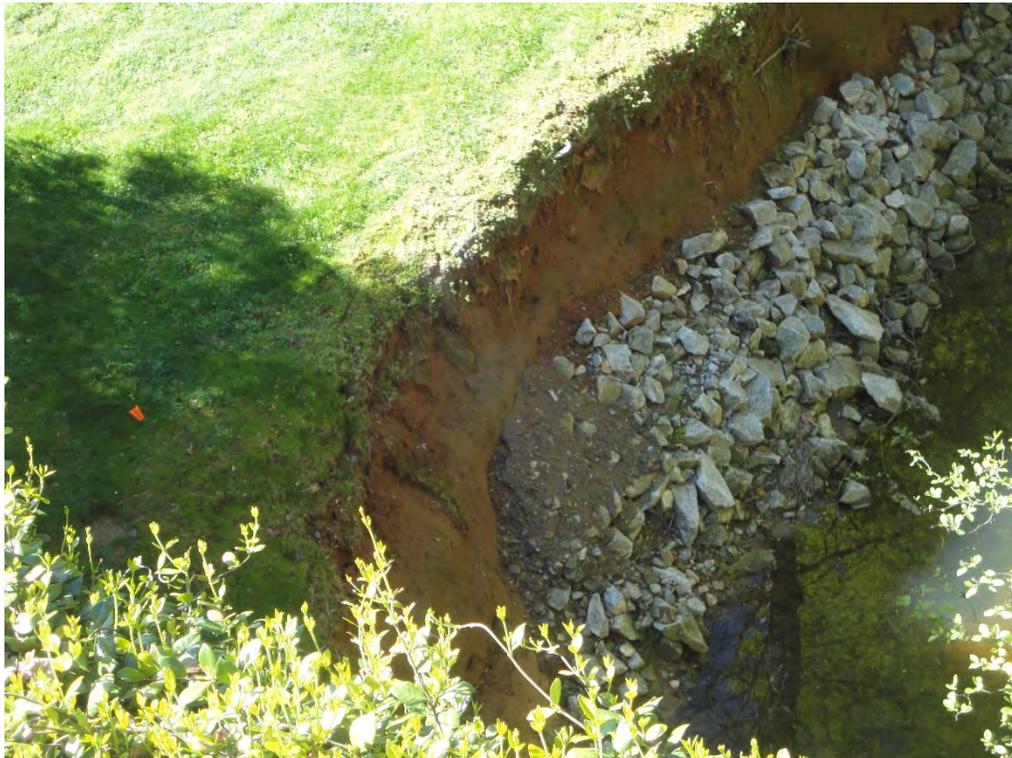
Boring HA-3 was performed just above an existing escarpment associated with the embankment instability west of the culvert and south of Peters Creek. This boring encountered low consistency residual soil throughout its entire depth. The recovered soil samples typically classified as wet, fine sandy silt (ML). Trace amounts of small roots were observed in some of the sampled residuum. The DCP resistances in the residual soil were low and ranged from 1 to 4 bpi.

Photo 6 - Near field view of embankment instability and rip-rap sloughing in Photo 5. HAB-3 in left side of photo.

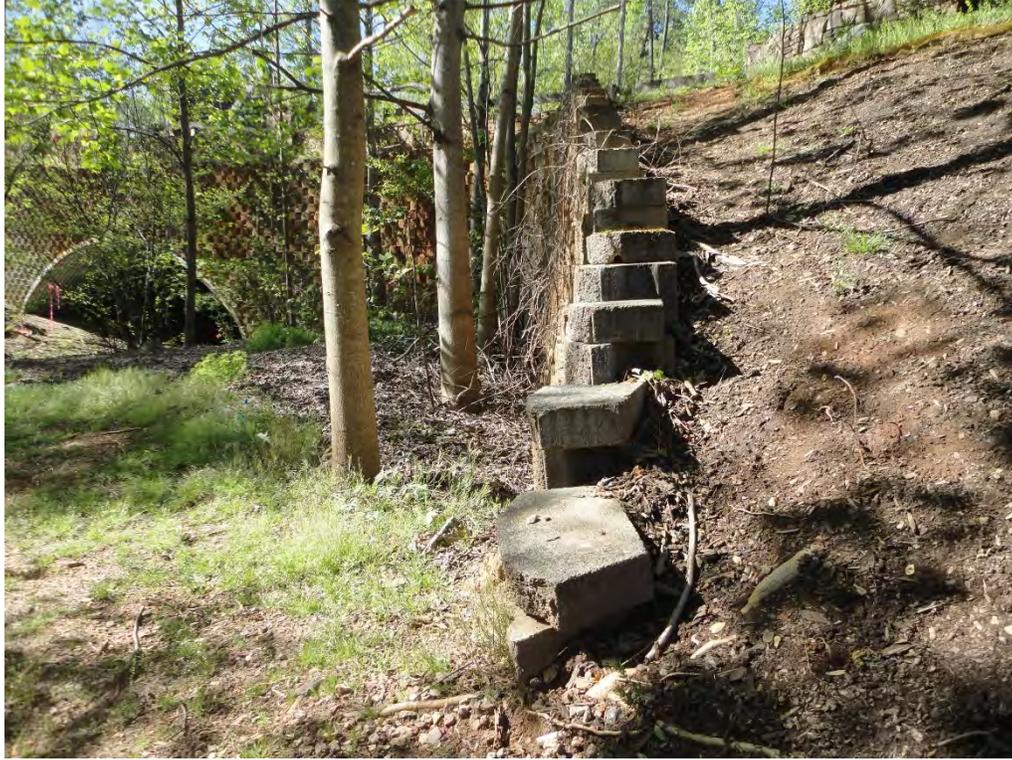
Photo 11 - Erosion and displaced cap block, north wing of east MSEW.

2. Areas of localized erosion above/behind the walls should be repaired. Properly compacted earth fills should be placed in all areas where the backs of the masonry blocks are exposed.

7. The abrupt wall termination at the end of south wing of the east wall should be modified to a gradual taper.
8. Displaced cap blocks should be reset with construction adhesive.

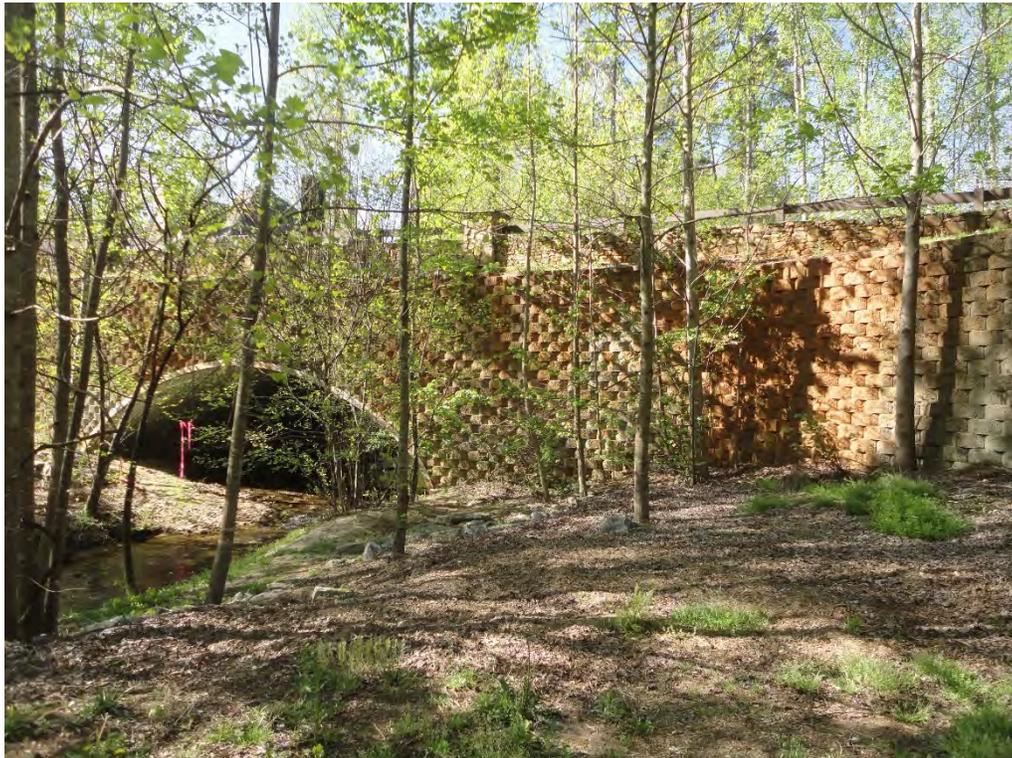
Photo 12 - Face of north wing of east MSEW. Note soil staining on face of wall.

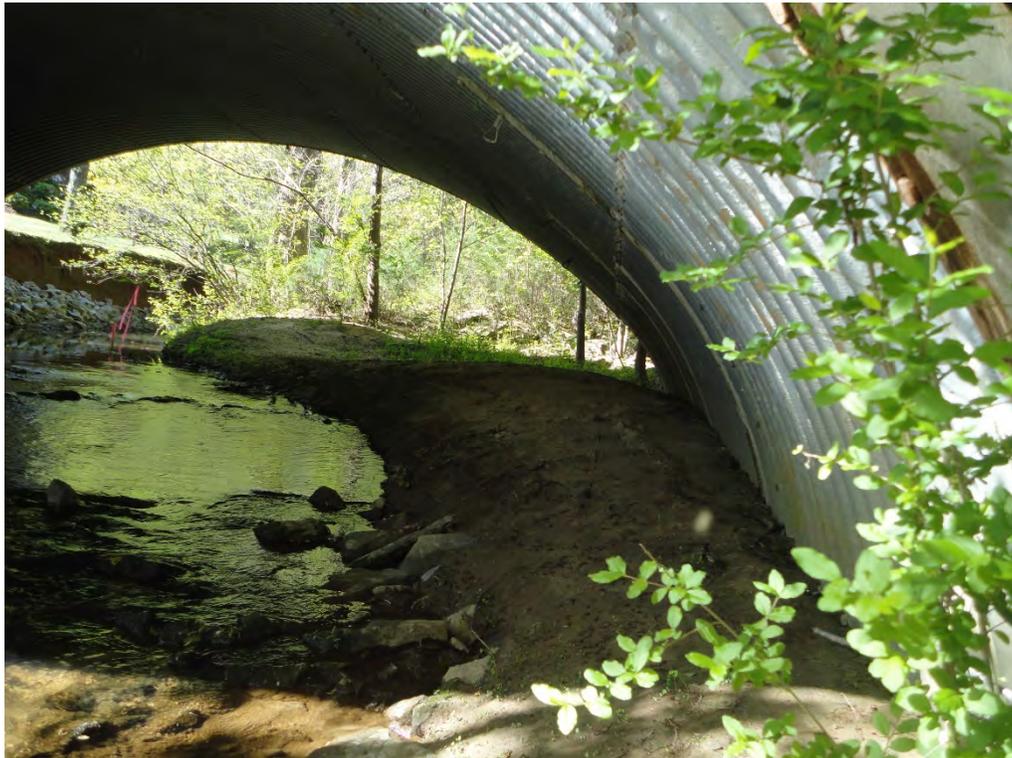
Photo 16 - Conditions beneath north end of culvert. Note area of embankment instability upper left side of photo.

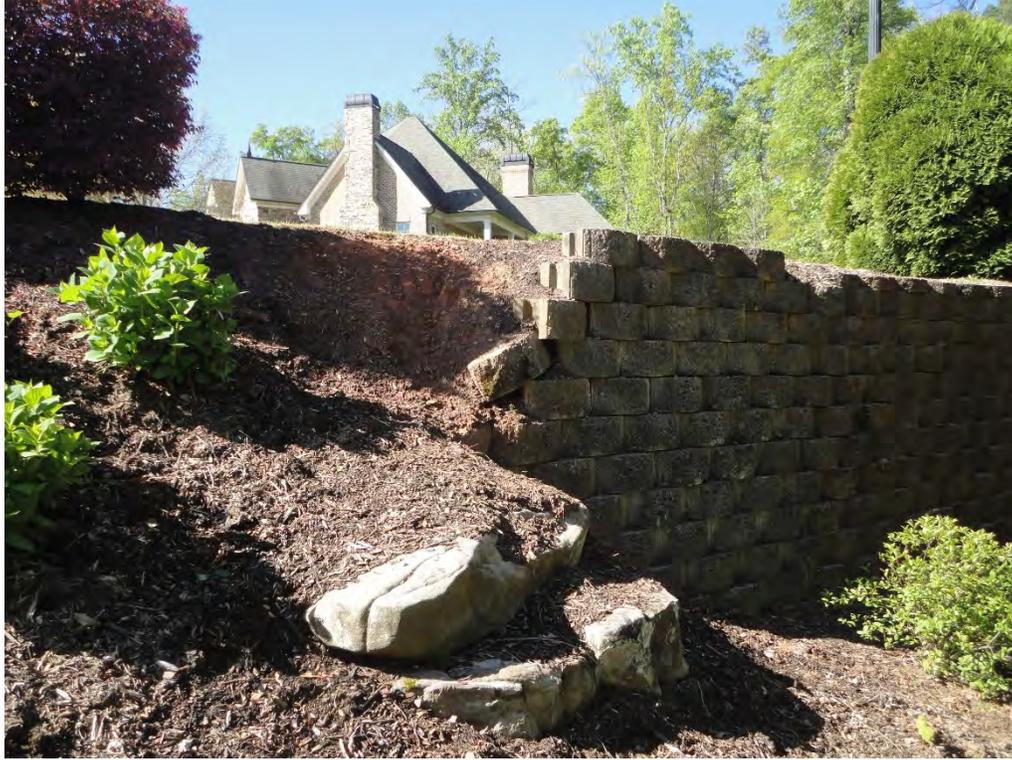
Photo 17 - Erosion, displaced block and missing cap blocks south end of west MSEW.

5. Vegetation that has overgrown the face of the MSEWs should be removed and periodic maintenance performed to limit future growth.
6. Displaced masonry units should be reset to the proper position/alignment.

9. Missing cap blocks should be installed and secured with construction adhesive.

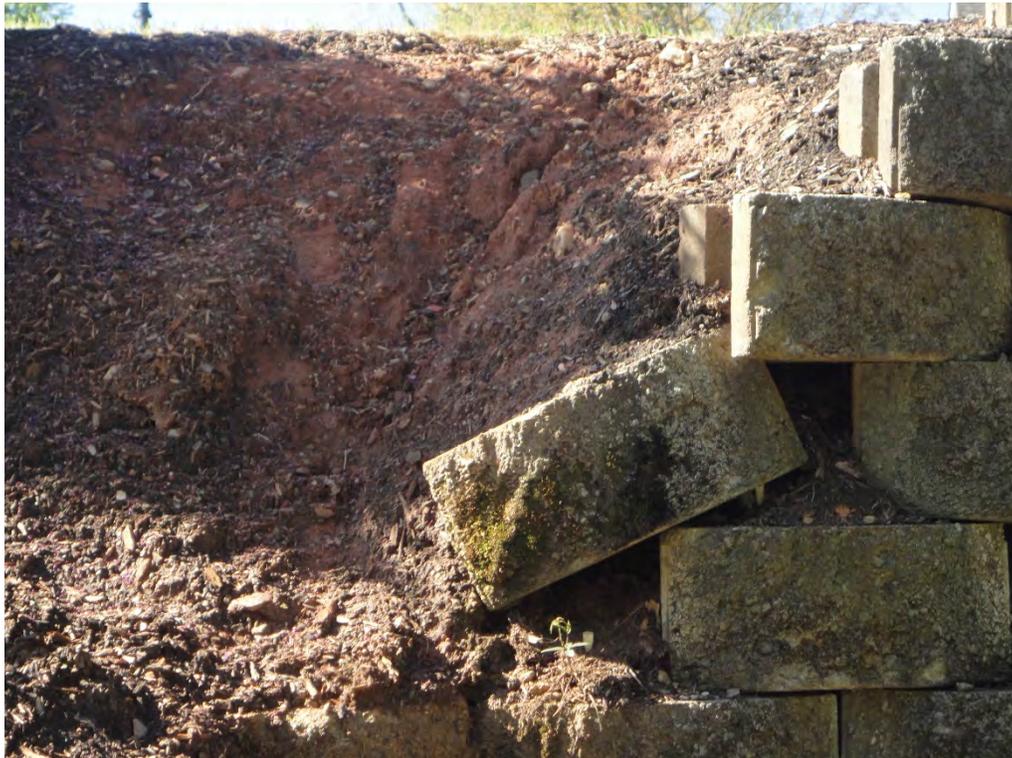
Photo 18 - Near field view of conditions in Photo 17.

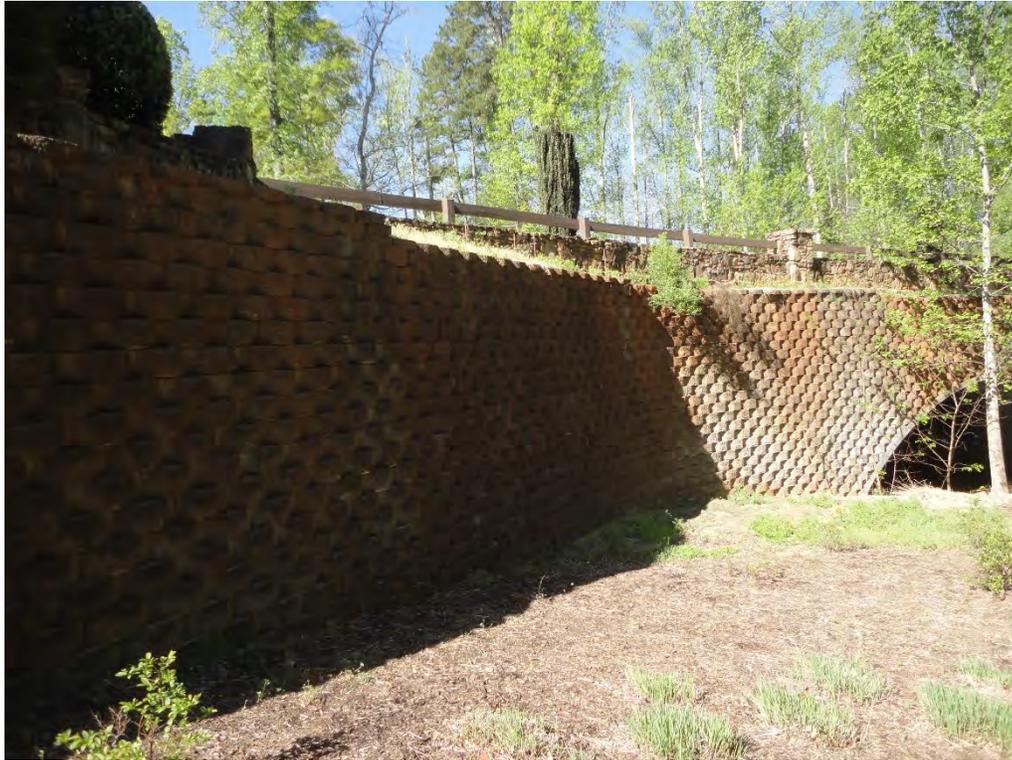
Photo 19 - Face of south wing of east MSEW. Note soil staining.

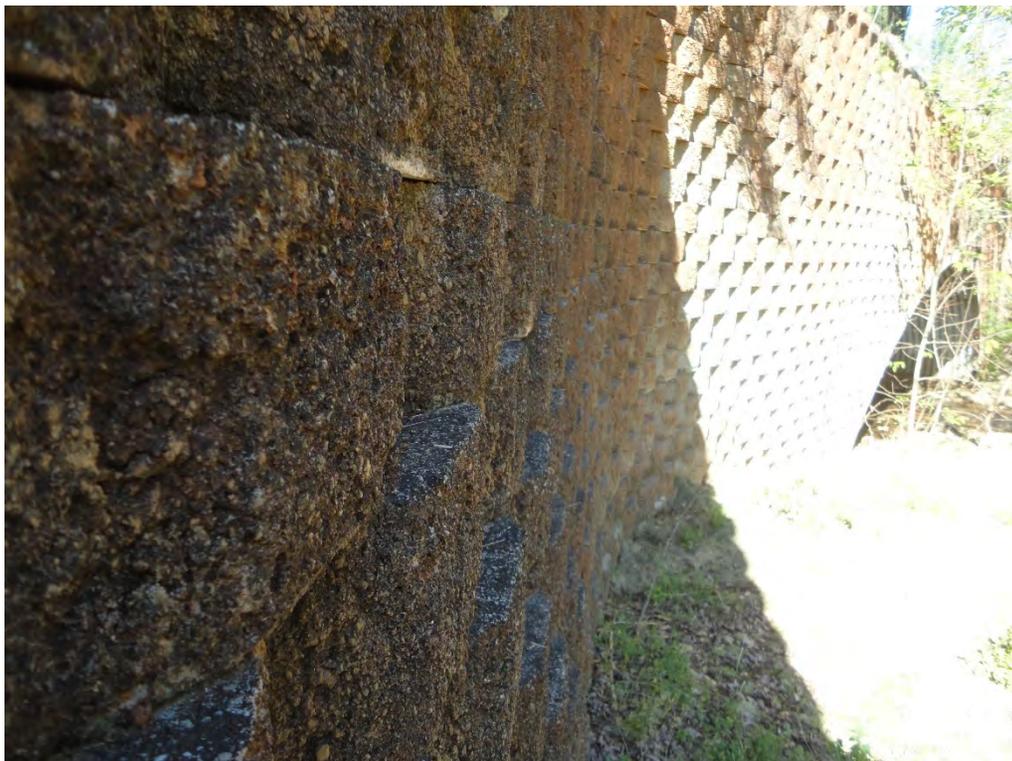
Photo 20 - Near field view of typical 1 inch setback per block.

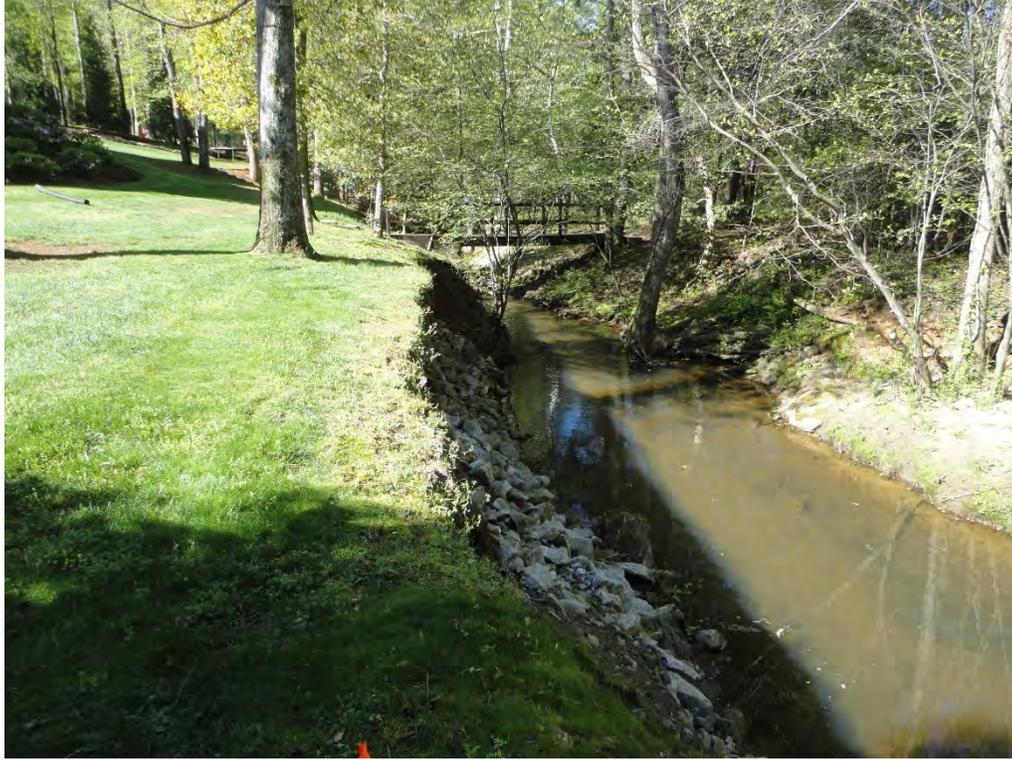
Photo 25 - Area of embankment instability west of south end of culvert.

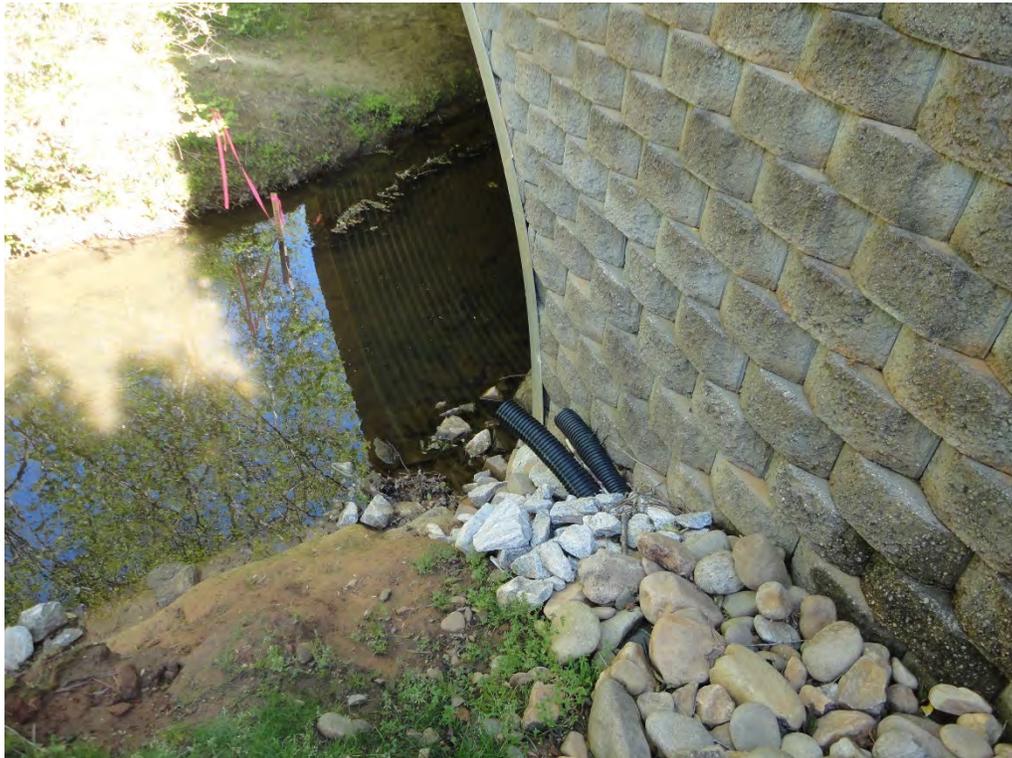
Photo 26 - River rock and corrugated drain pipes along toe of south wing of east MSEW just above stream.

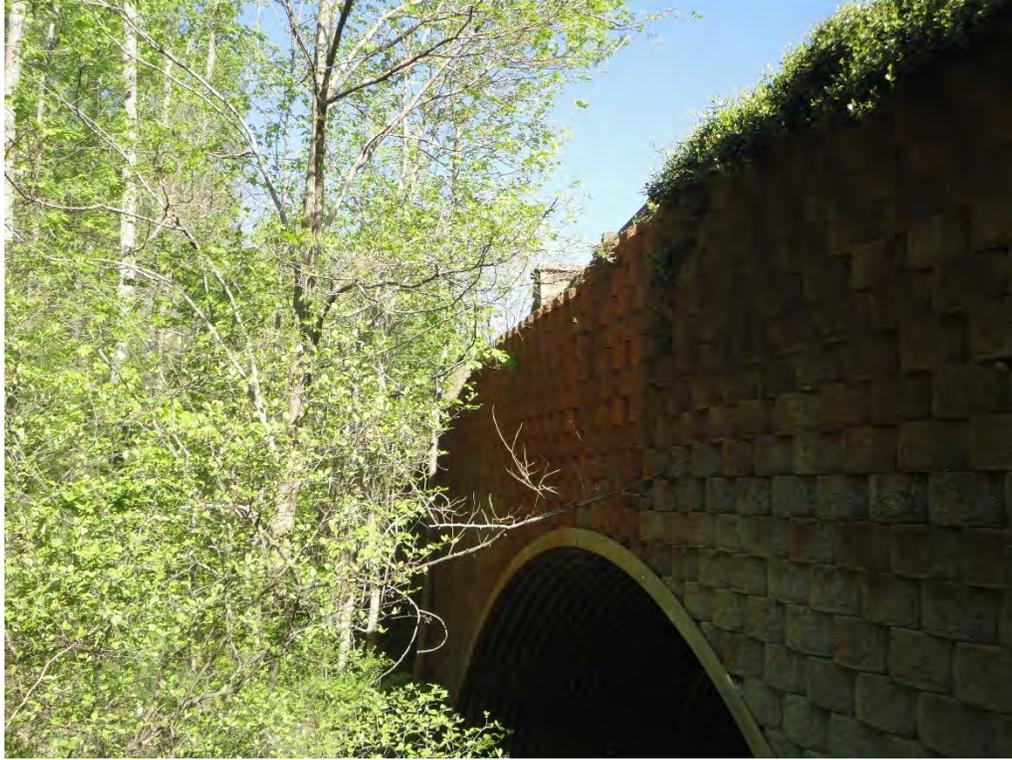
Photo 27 - Soil staining on face of west MSEW above culvert.

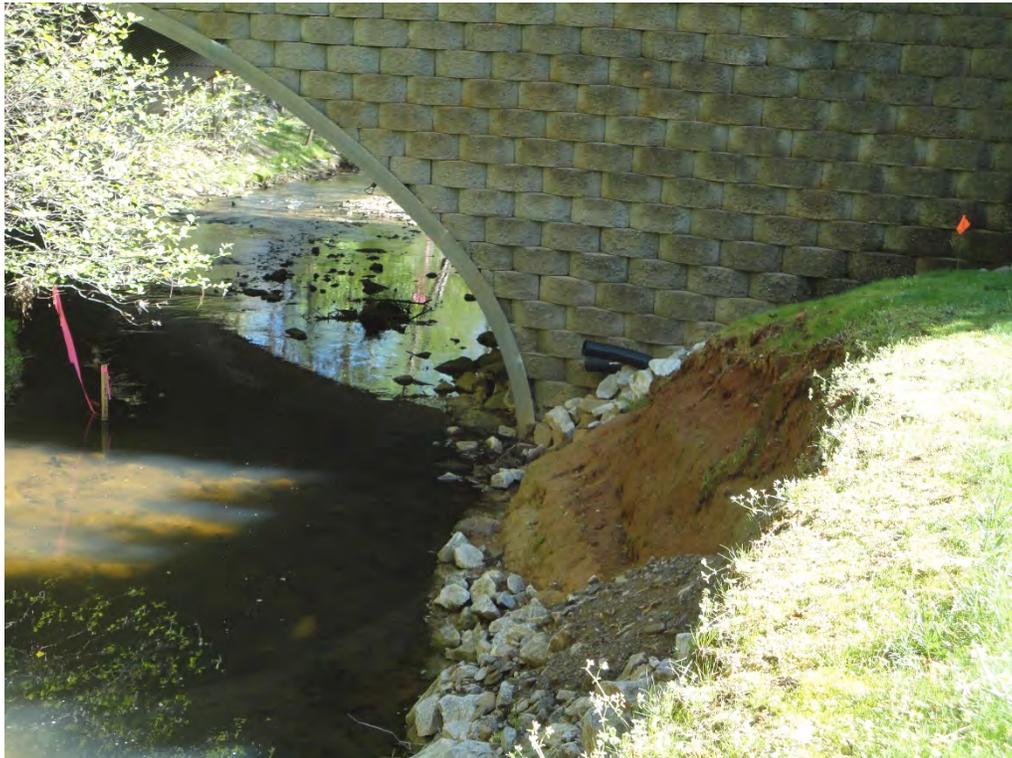
Photo 28 - Near field view of embankment instability looking east toward culvert.

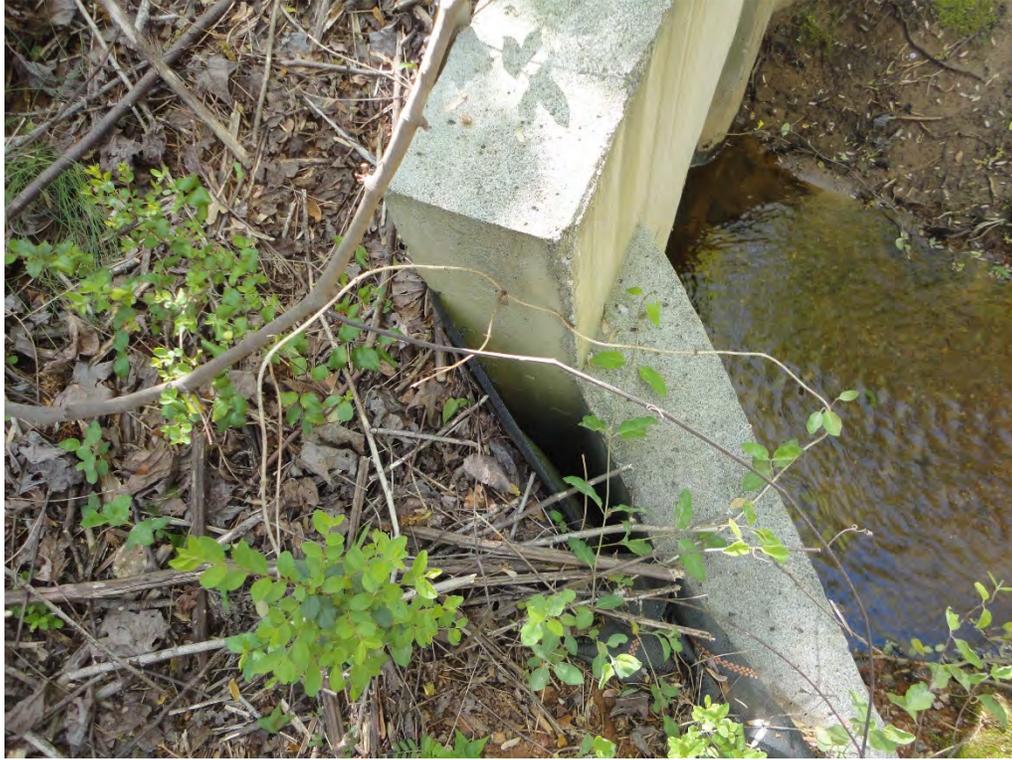
Photo 31 - Void immediately behind concrete wing wall.

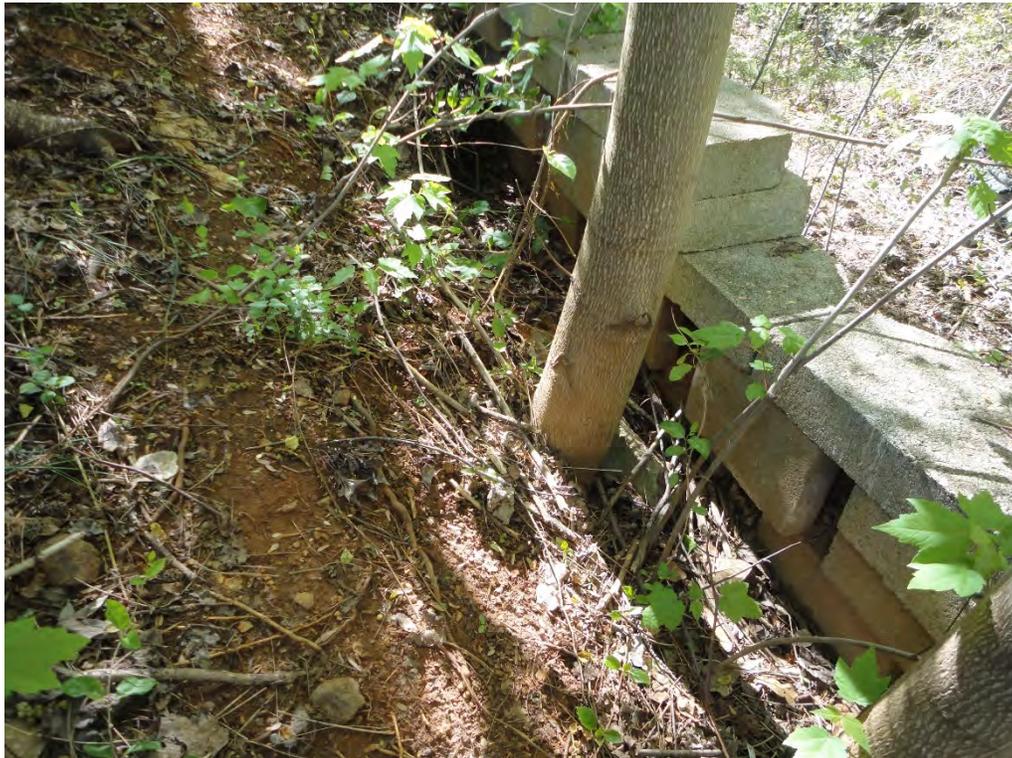
Photo 32 - Mature vegetation immediately behind north end of north wing of east MSEW.

3. Woody vegetation within 3 feet of the top of the MSEWs should be removed and periodic maintenance performed to limit future growth.
4. Woody vegetation within 3 feet of the toe of the MSEWs should be removed and periodic maintenance performed to limit future growth.

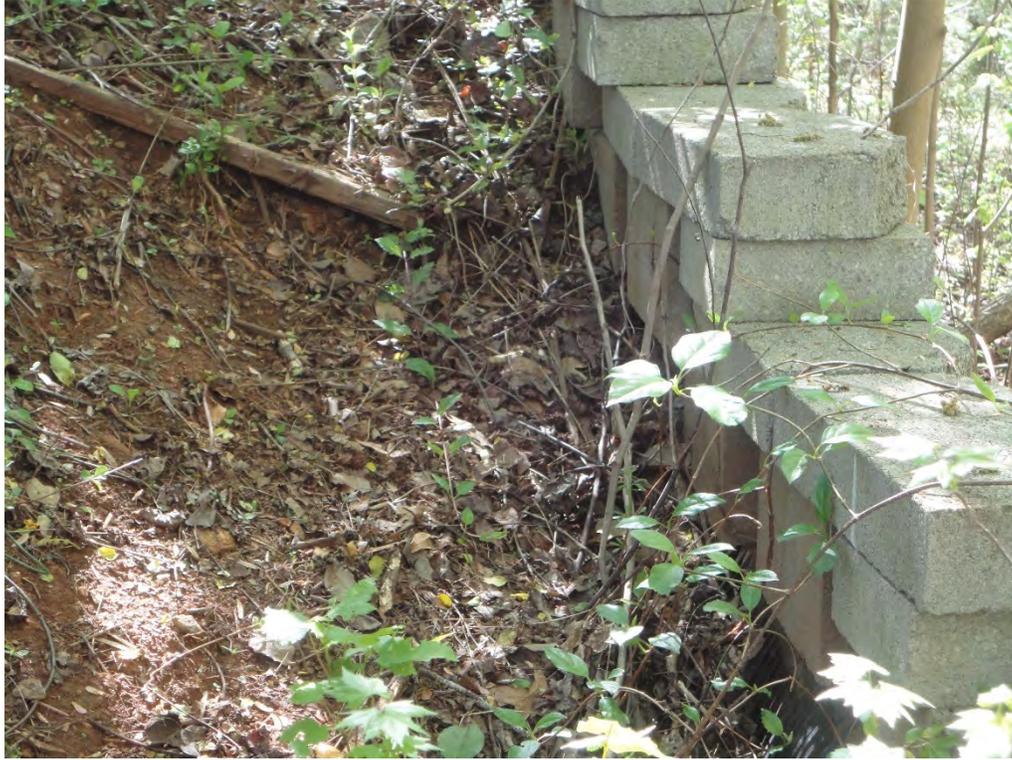
Photo 33 - One to two course of exposed block back side of east MSEW above north wing.
