FULL RESERVE STUDY

The Plantation on Pelham Property Owners Association, Inc.

Greenville, South Carolina

August 6, 2015

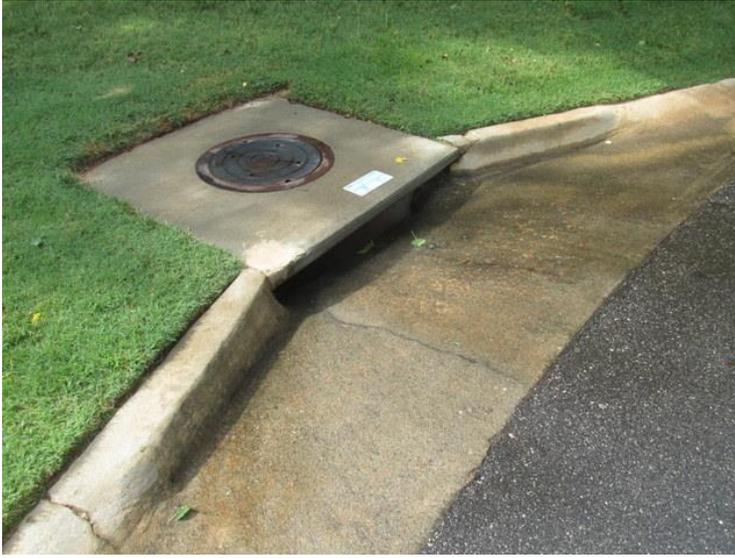
Asphalt pavement – Micasa Court

Note: Cracks at cul-de-sac

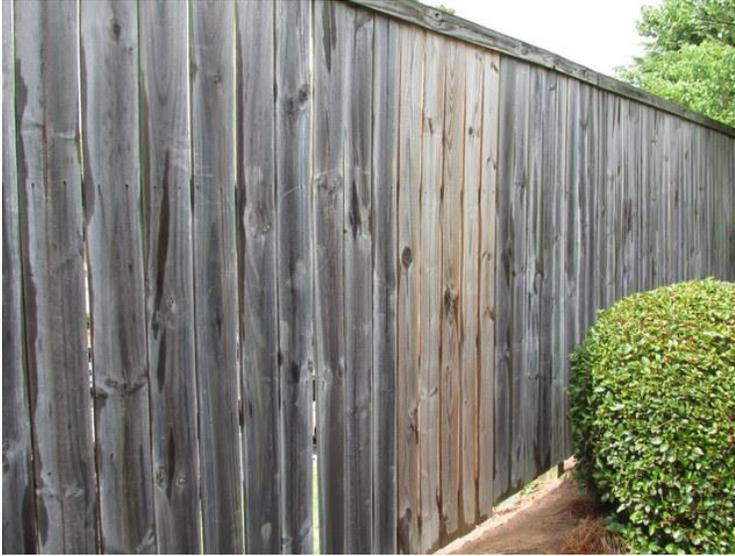
Wood fence at northwest perimeter of property

Note: Separated and warped wood member

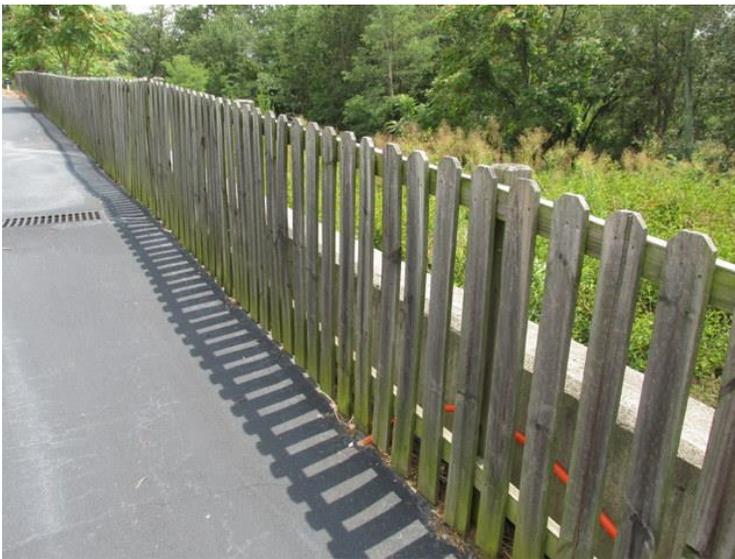
Wood fence at northwest perimeter of property

Note: Replaced section

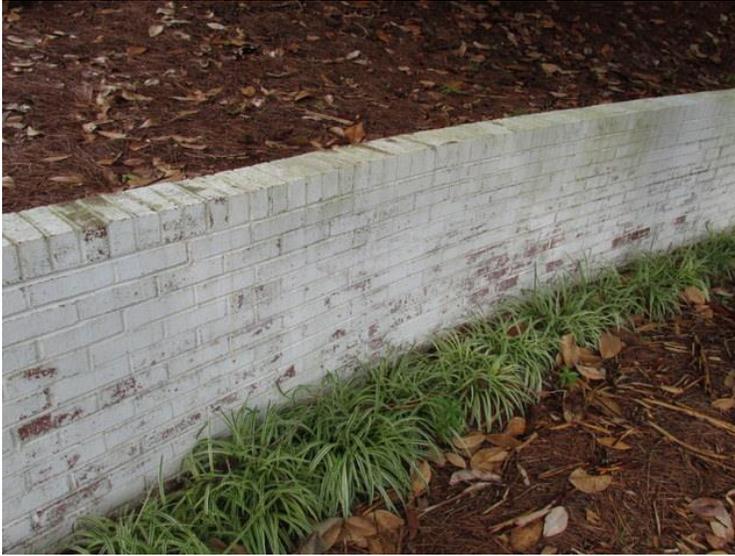
Masonry wall at community entrance

Note: Poor paint finishes

4.810	6	6	Each	Signage, Street and Traffic	2023	15 to 20	8	750.00	4,500	4,500	14,467															5,483											
4.871	1,500	1,500	Square Feet	Walls, Masonry, Entrance, Paint Finishes and Repairs	2016	4 to 6	1	3.00	4,500	4,500	38,524		4,612					5,219							5,904												
Exterior Clubhouse Elements

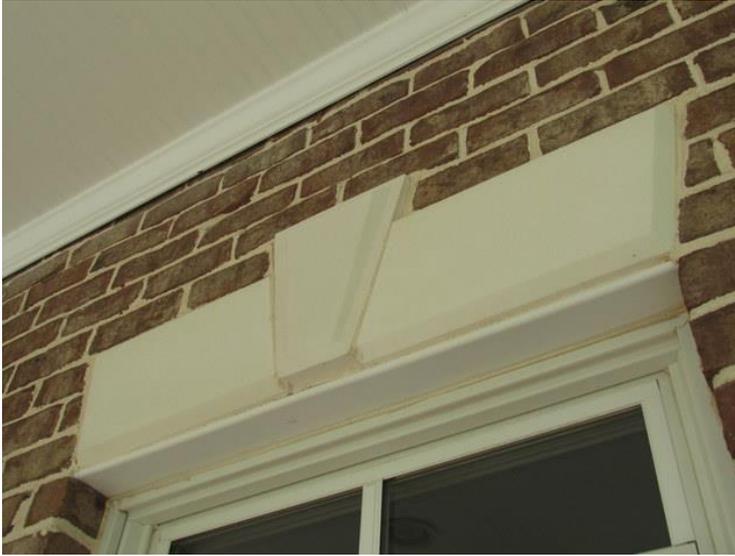
Exterior masonry wall and vinyl cladding at lintel

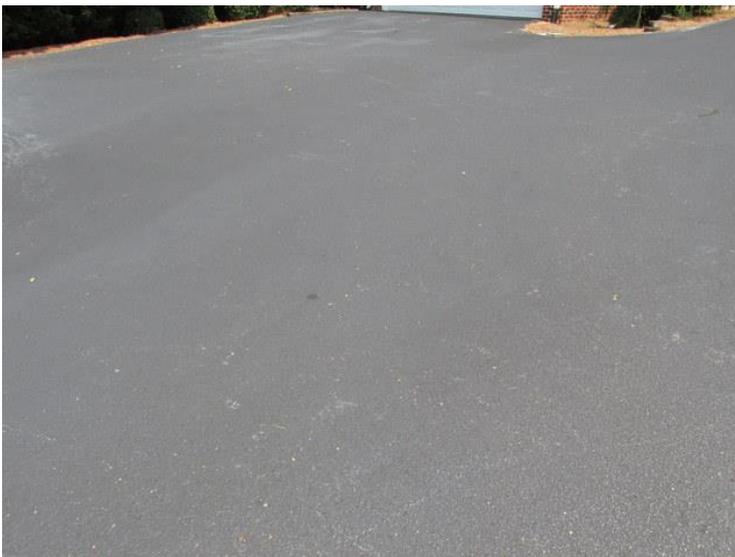
Asphalt pavement at alley

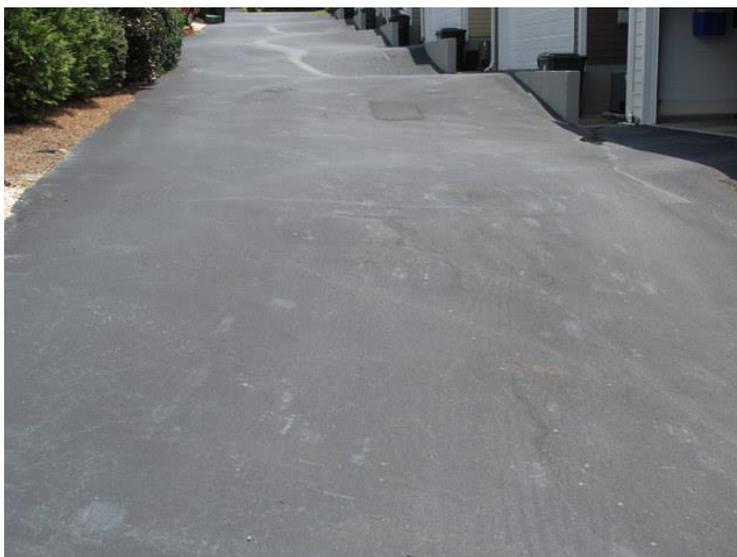
Asphalt pavement at alley

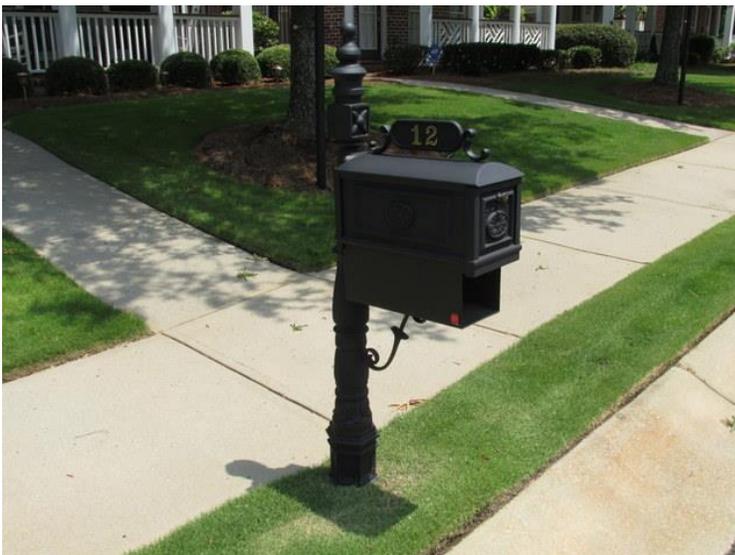
Typical mailbox at townhomes
